Coast of Lake Erie

LITTORAL PROCESSES AND SEDIMENTATION  
IN THE CATTARAUGUS EMBAYMENT, New York

9  
Final Report for Contract

U. S. Army Engineer District, Buffalo

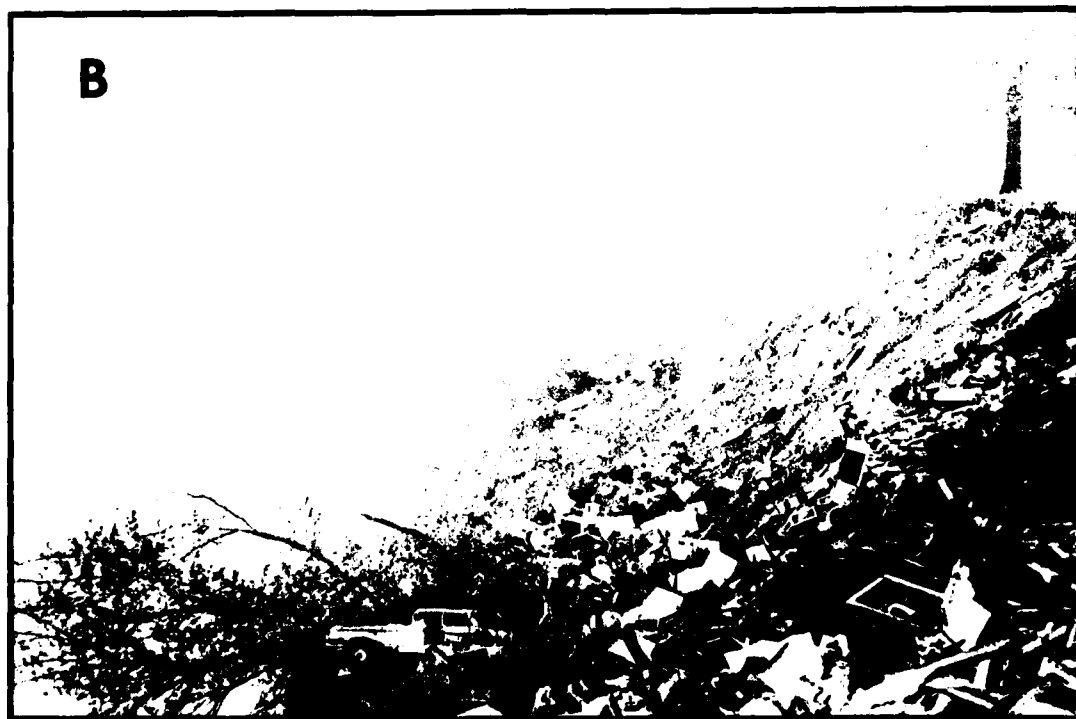
FIGURES 5A AND B

- Figure 5. A. Eroding cliff at zonal study site #2 (Fig. 2). This site is located approximately 3 miles east of Fairport Harbor, Ohio.
- B. Cliff near area shown in aerial view (A). Note intensive slumping of the cliff.

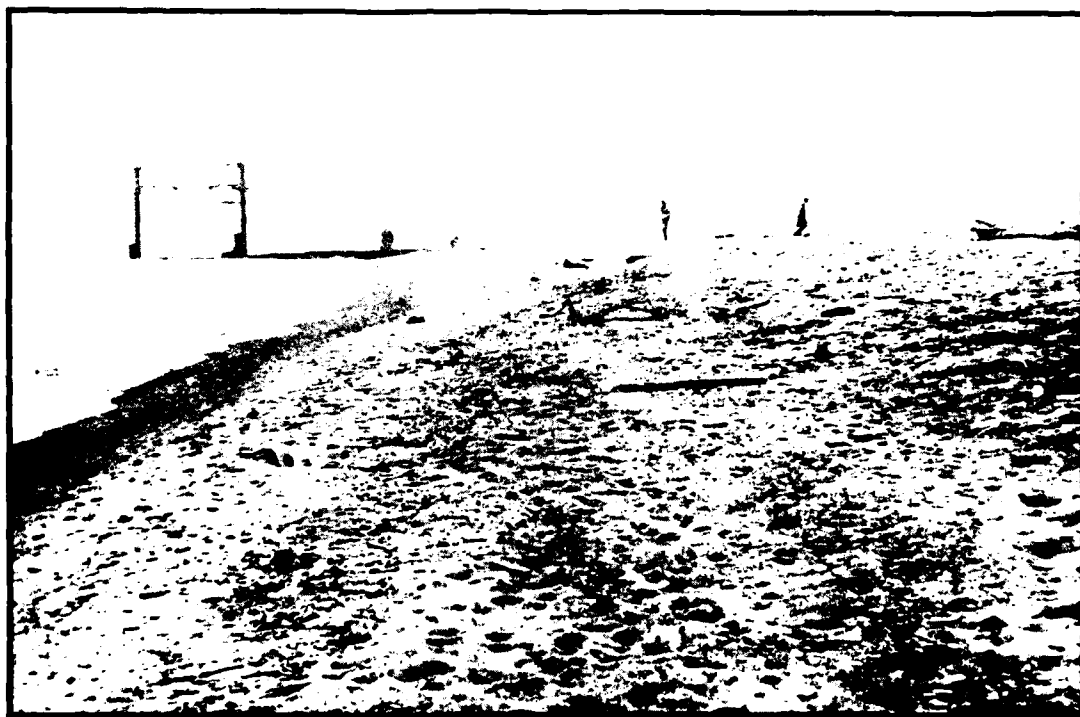
FIGURE 7

Figure 7. Area updrift of the groin at zonal site #3.  
View looks east-northeast. Compare with profile  
B in Figure 6.

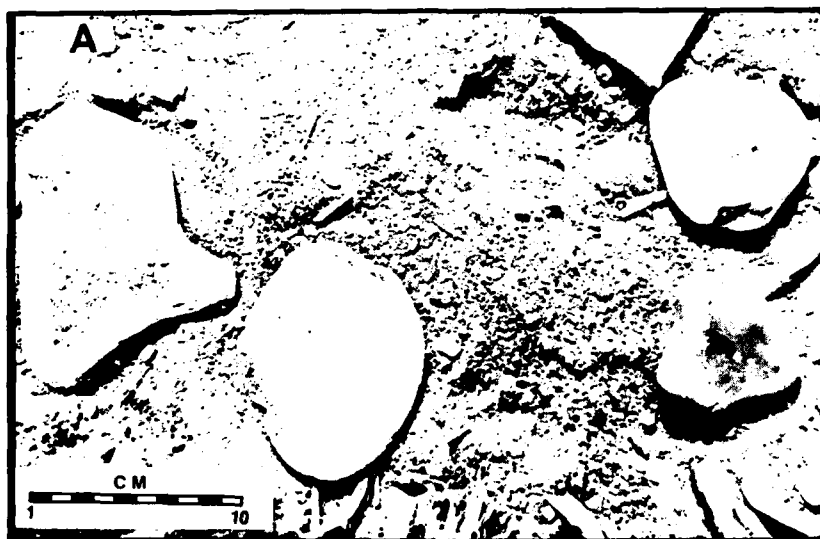
FIGURES 13, 13A, B, C, D AND E

Figure 13. Beach profile and sample photographs at zonal site #6 (see location of profile on aerial photograph in Fig. 12). Coarsest material occurs on the highest berm and grain size diminishes gradually toward the swash line.

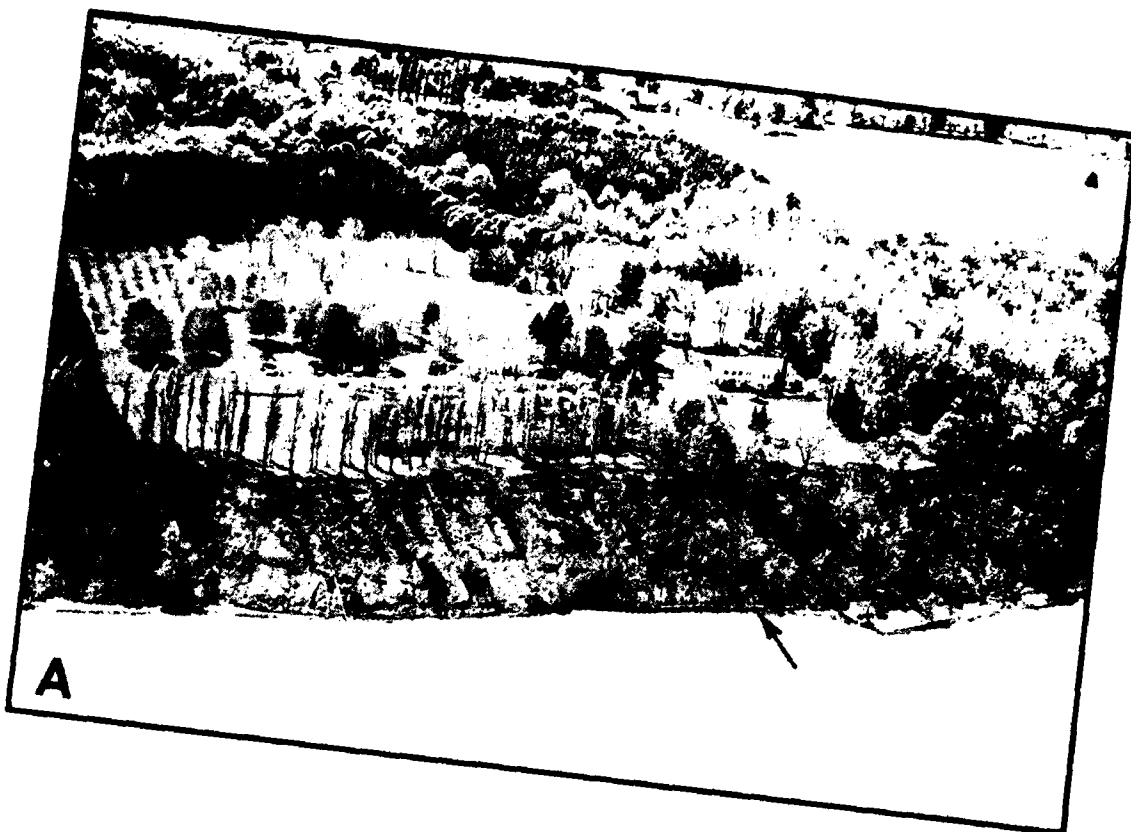
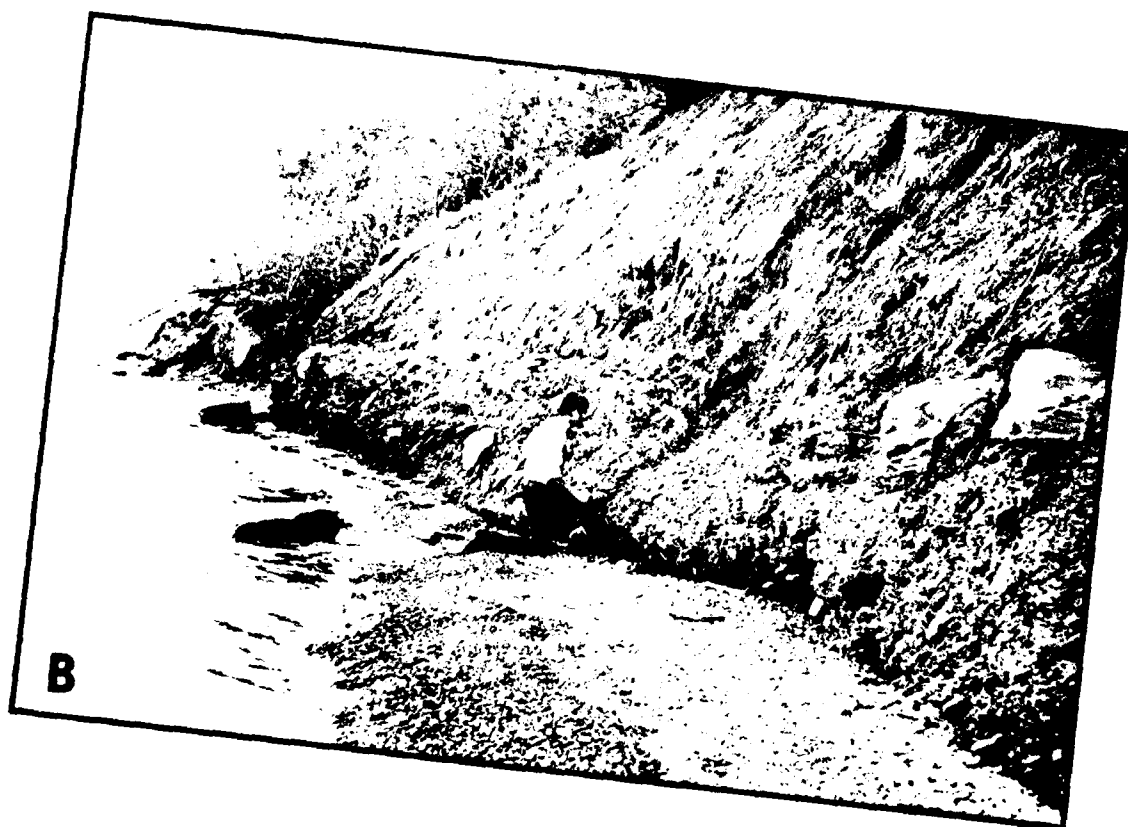
FIGURES 14A AND B

- Figure 14. A. Zonal site #7, near Fairplain, Pa. The cliff is 70-80 feet high at this location. Note the erosion downdrift of the small groin in the right foreground. Arrow points to locality shown in photograph B.
- B. Base of cliff at zonal site #7. Coarse-grained till at base of cliff is approximately 5 ft. thick.

eroded severely on both sides of the groin since that time. Refer to aerial photograph in Figure 14A. This type of private protective structure is very common along this section of cliffs.

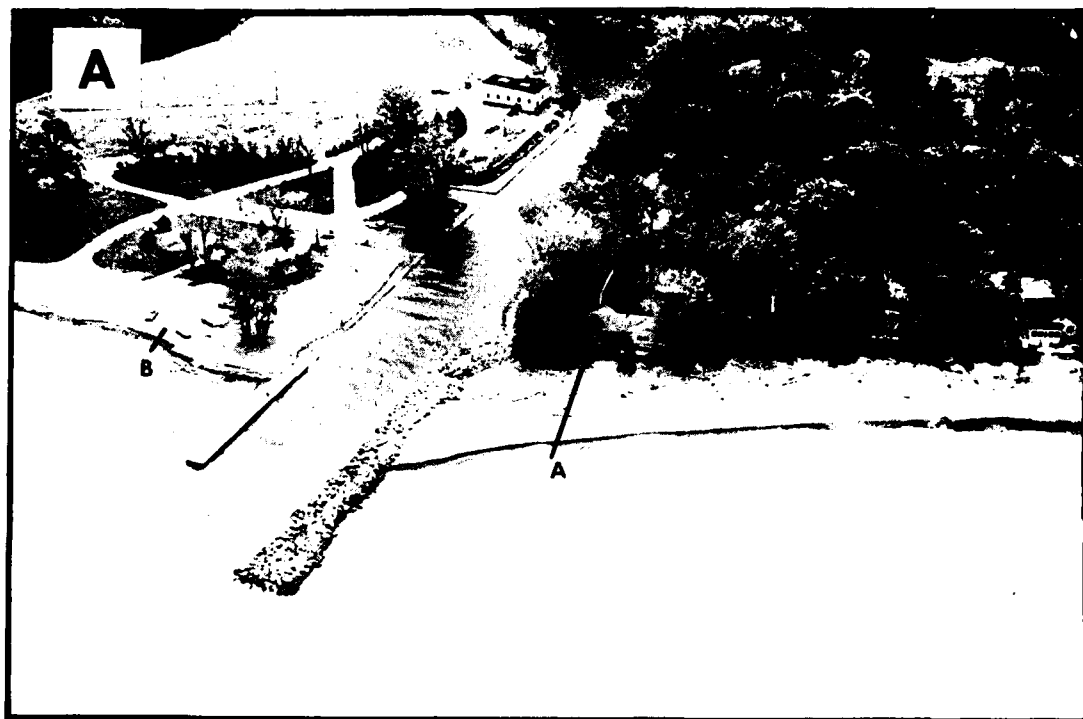
FIGURES 18A AND B

B. Beach profiles on updrift side (profile A) and downdrift side (profile B) of the Walnut Creek jetties. Note abundance of gravel berms in profile A.

- Figure 19. A. Beach zone just updrift of the Walnut Creek jetties. Note multi-level gravel berms. Compare with profile A in Figure 18B.
- B. Beach zone just downdrift of the Walnut Creek jetties. Blocks of the parking lot pavement occur several feet offshore. Compare with profile B in Figure 18B.

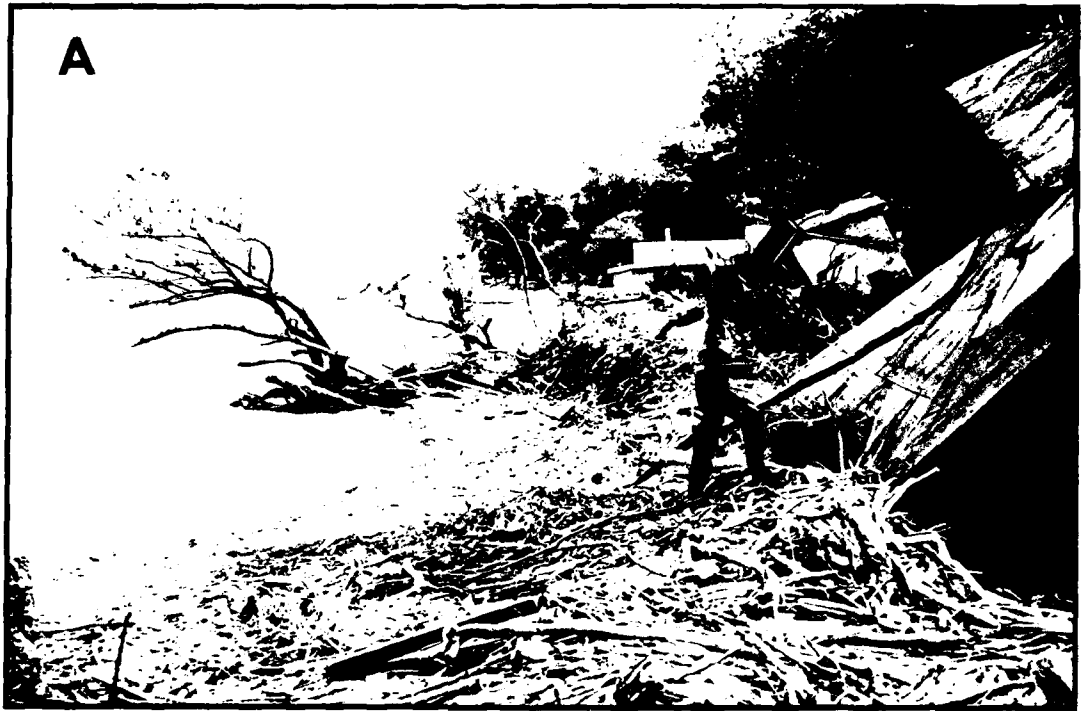
FIGURES 20 A AND B

- Figure 20. A. Intense erosion zone one-half mile west of Presque Isle, Pa. (zonal site #10). The geologist is standing on a gravel berm built up onto the rooftop after the house collapsed. Note natural groin effect of the log jam in the middle distance.
- B. Beach zone 200 feet west of the area shown in A.

a storm berm of coarse gravel has been deposited in front of them. This berm can be seen in the photograph in Figure 20A. The gravel at this locality, as at most of the other localities along this stretch of shore, consists of discoidal siltstone.

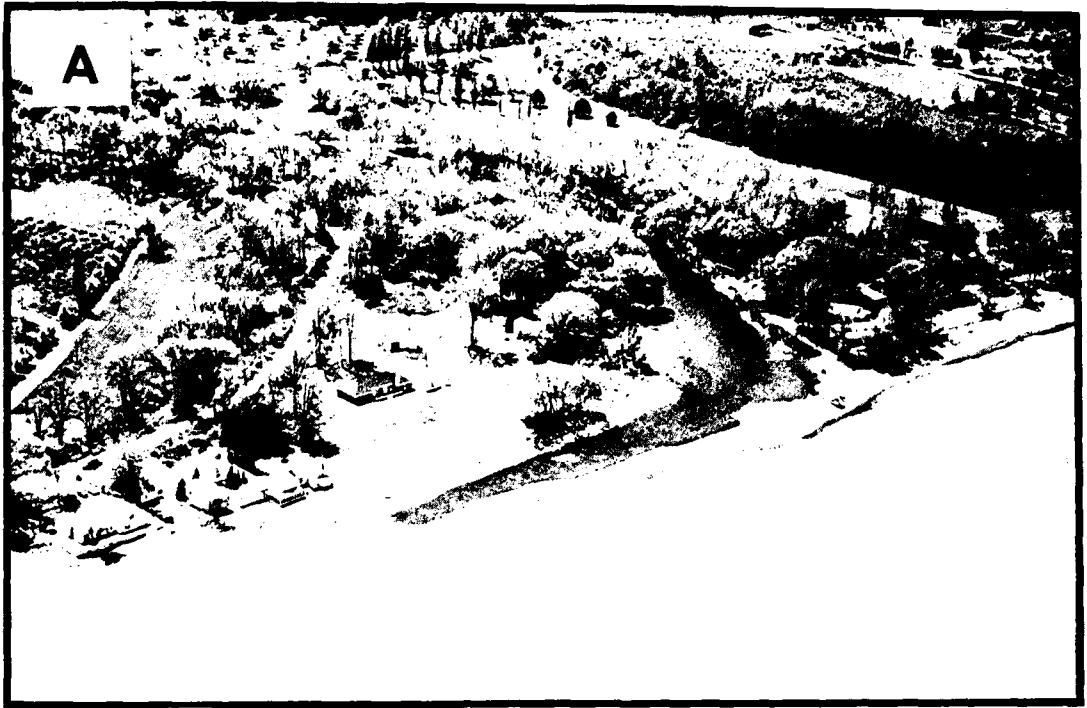
FIGURE 25

- Figure 25. A. Zonal site #14, mouth of Twentymile Creek, Pa. Note long rivermouth spit projecting northeastward across the mouth of the stream. A three-dimensional block diagram of the spit is given in Figure 26.
- B. View along rivermouth spit shown in A (looking southwest).

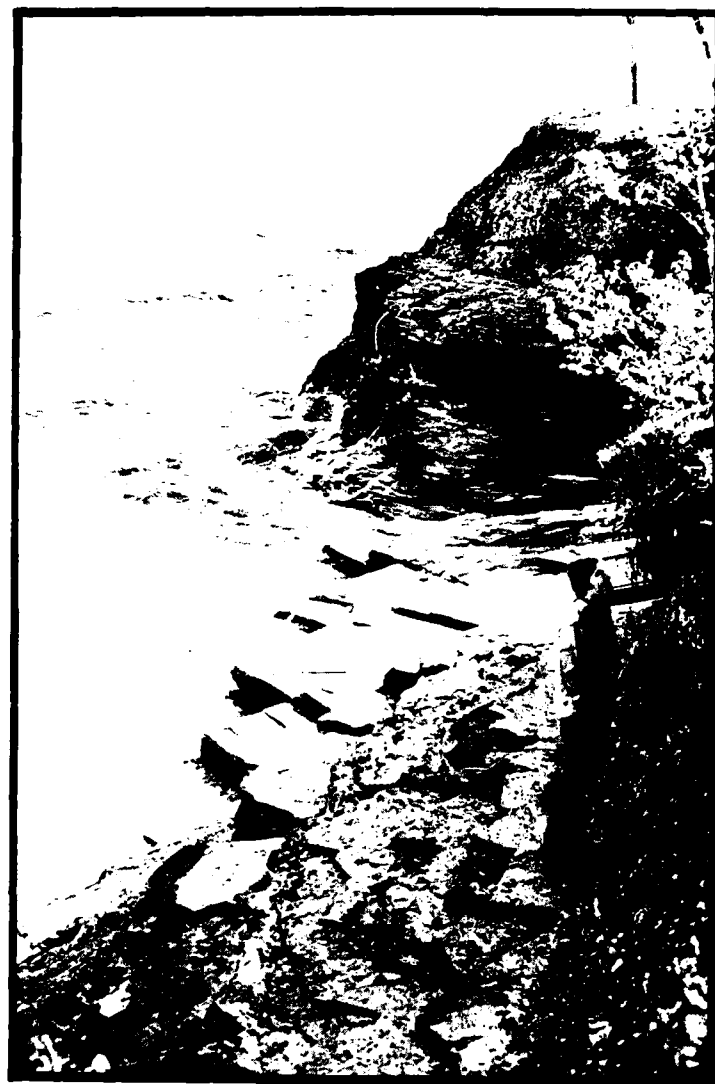
FIGURE 28

Figure 28. Rock cliff at zonal site #15, Blue Water Beach, N. Y. Note well developed joint pattern in the shale. Two joint trends predominate, N 60° E and N 10° W.

Zonal site #15 is located in a bedrock cliff area at Blue Water Beach. The most conspicuous feature in the cliff is the intensive jointing pattern which is illustrated in the photograph in Figure 28. Two primary joint directions were noted, N 60° E and N 10° W. These two joint directions control the orientation of the cliff faces on a local scale. The height of the cliff at this locality is 19.5 ft. The contact between the bedrock and the till occurs at 10.6 ft. above the water level. The bedrock consists of interlayered siltstones and mudrock. This has been an area of considerable erosion over the past few months. According to a local resident, a 75 ft. wide beach composed of sand and gravel was present as recently as the summer of 1973.

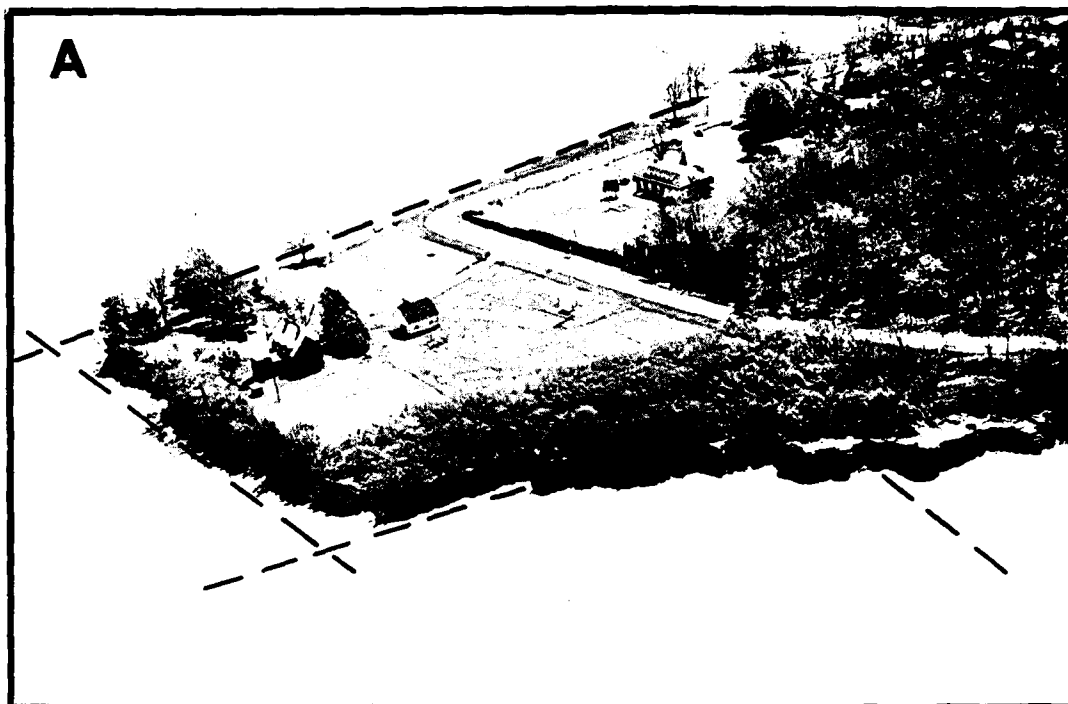
FIGURES 29A AND B

- Figure 29. A. Joint-controlled topography on headland just south of Dunkirk, N. Y. (lighthouse is Dunkirk Light). The two shoreline trends, indicated by the dashed lines, conform with the two major joint patterns measured in the shale bedrock ( N  $10^{\circ}$  W and N  $60^{\circ}$  E; see B).
- B. Joint patterns measured at Bluewater Creek and Van Buren Point, N. Y.

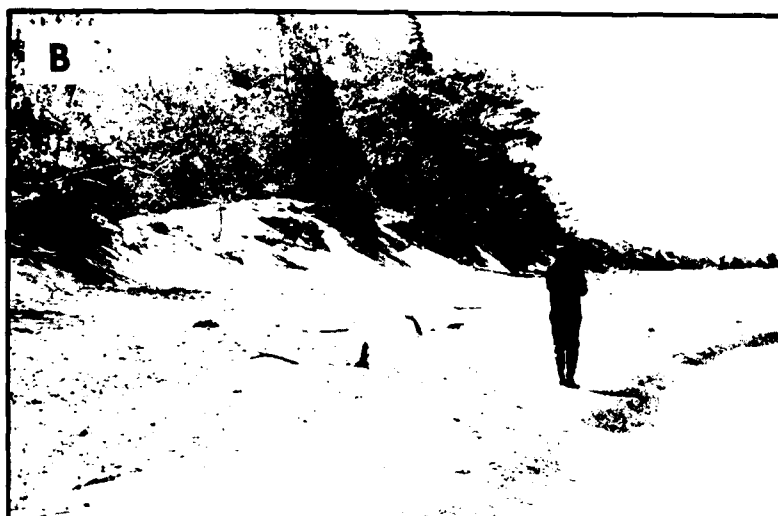
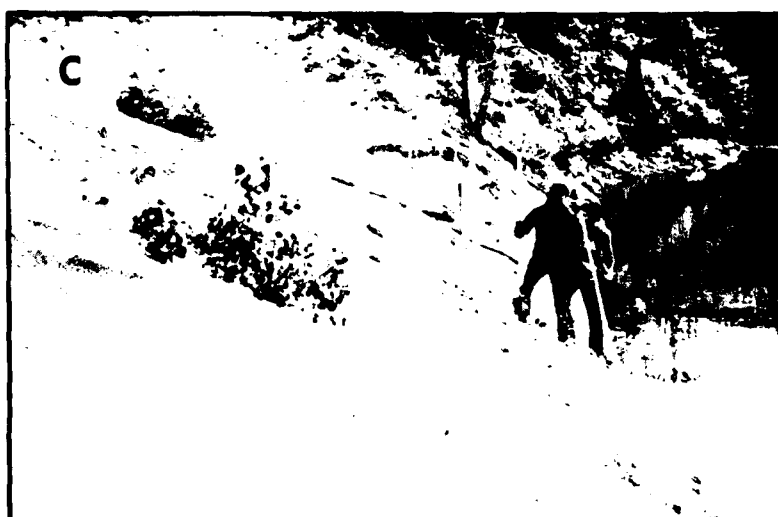
FIGURES 35A, B AND C

- Figure 35. A. Dune and beach profile extending from the lagoon of Big Sister Creek to the lake. The profile is located by arrow B on the aerial photograph of Figure 34A. The peaked central area is an eroding dune ridge.
- B. Beach zone of profile shown in A. Note gravel accumulations on berms.
- C. Slip face on dune at landward margin of profile given in A. Big Sister Creek can be seen on the right.

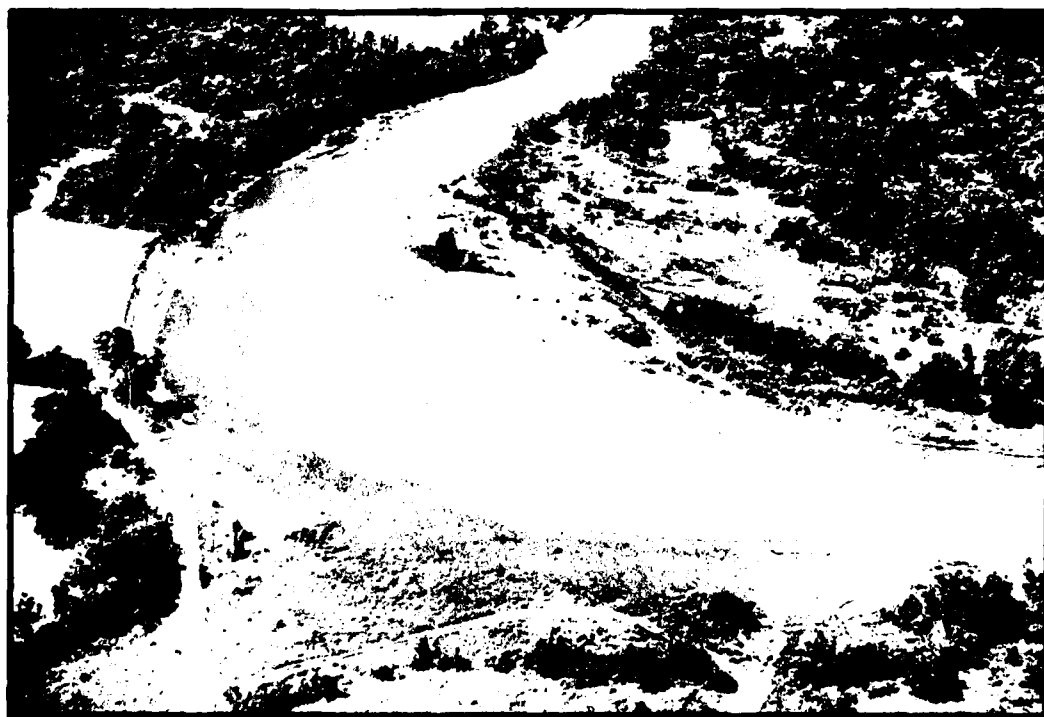
PLATE 2

Plate 2. Aerial view of a Cattaraugus Creek gravel point  
bar. The dominant lithologies are siltstone, red  
sandstone, limestone, and a few crystalline rock fragments.  
Typical gravel size on the point bar in the picture is  
5 centimeters. Photo: June 13, 1974.

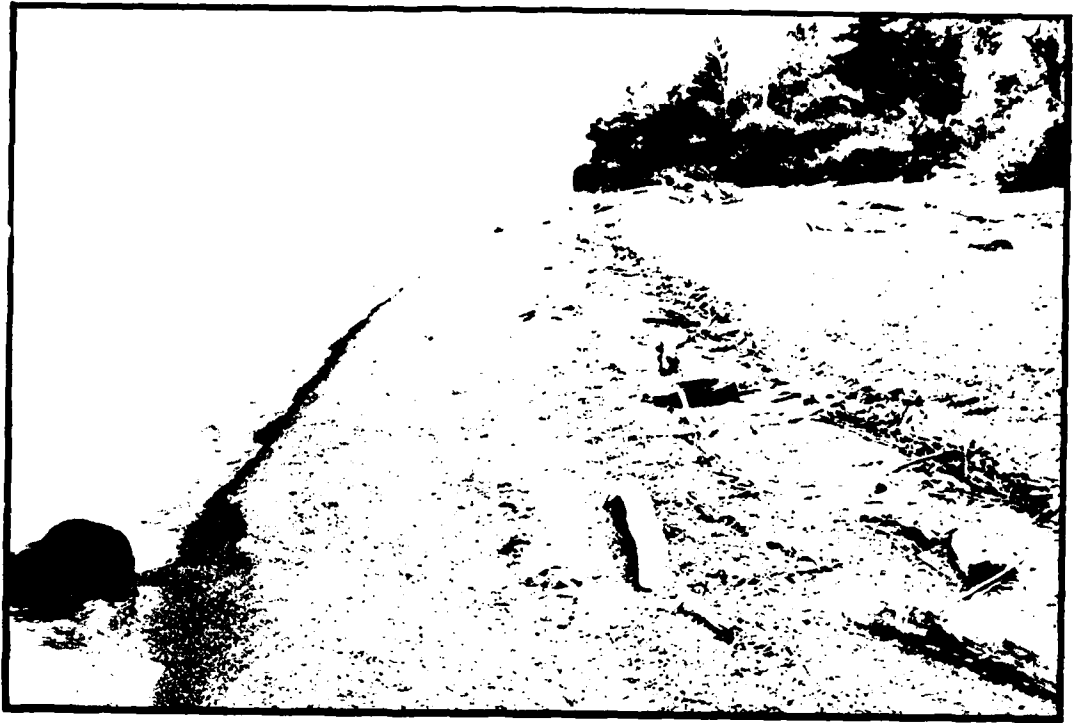
PLATE 3

Plate 3. Wide beach. View northward from profile location Cat. 10 towards Lotus Point. Despite the proximity of the shale headland the lithological composition of the gravel at Cat. 10 is the same as that much further to the south. Note the multiple gravel berms. Photo: May 23, 1974.

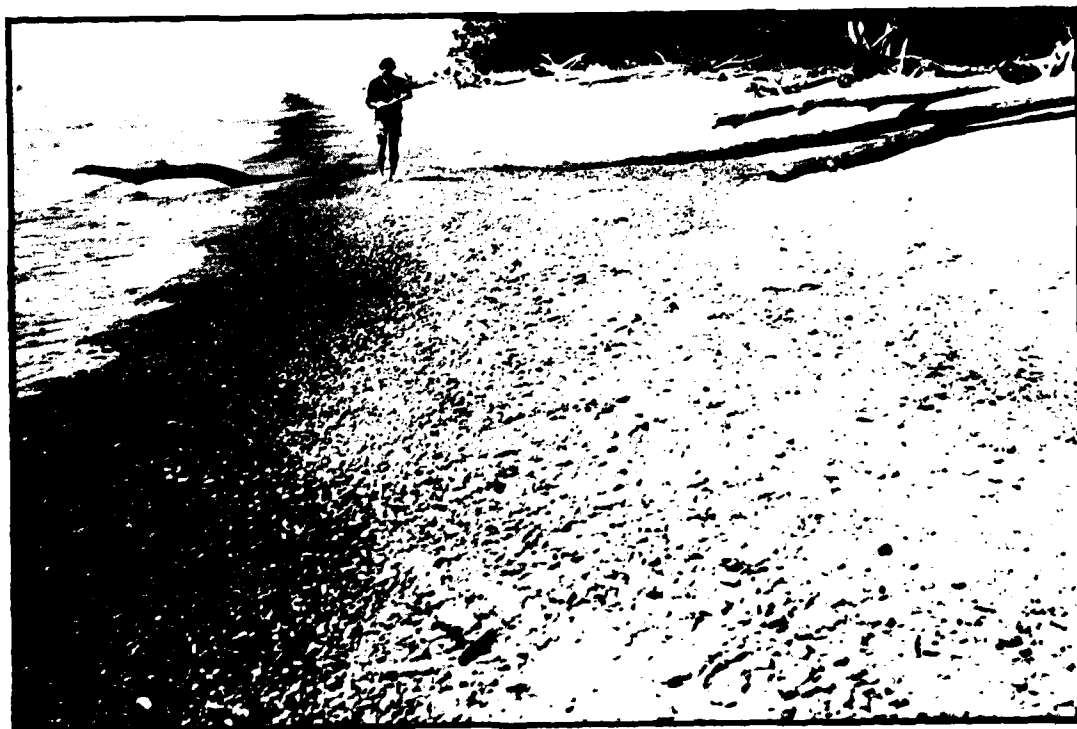
PLATE 6

Plate 6. Beach face at Cat. 6. A wide gravel berm becoming more sandy as it grades into the back beach is typical of the constructional beaches in the Cattaraugus Embayment. The change from the previous photo was accomplished in less than 24 hours. Photo: June 12, 1974.

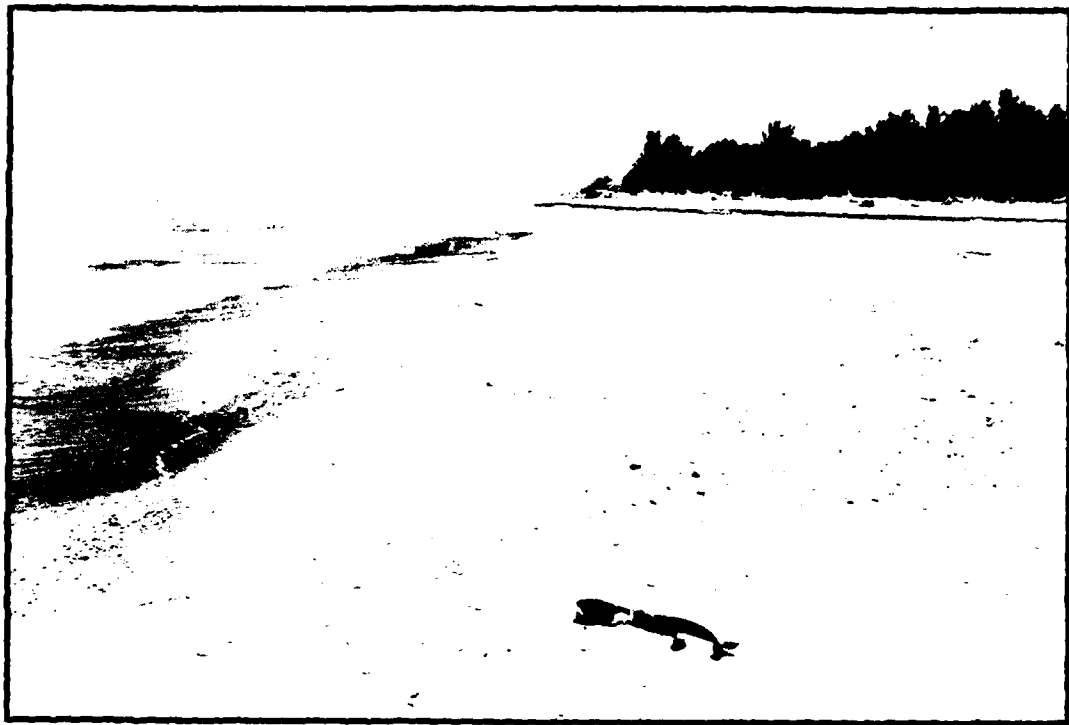
PLATE 7

Plate 7. View towards the north of the beach at profile location Cat. 5. Note multiple gravel berms and the sandy swash zone. Waves are breaking over the sub-aqueous spit at the upper left of the photo.  
Photo: June 12, 1974.

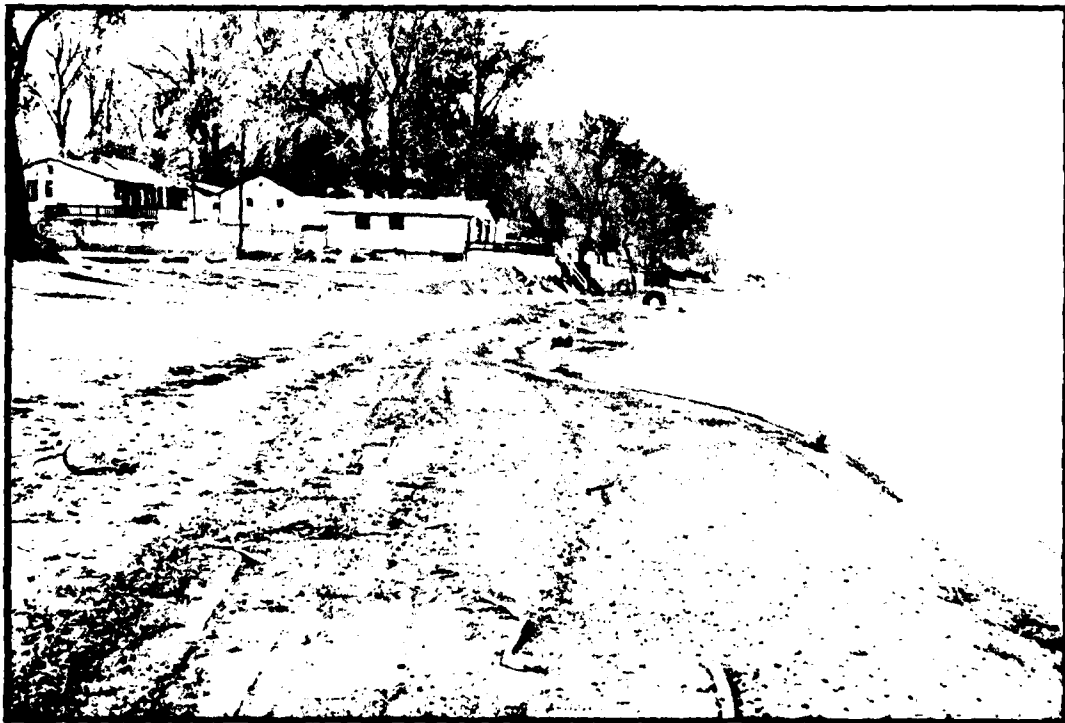
PLATE 8

Plate 8. View towards the south of the beach at profile location Cat. 5. Note the wide berm in the foreground which was welded onto the beach face by a ridge migrating landward during the waning stages of the storm. Photo: June 12, 1974.
